## Experts describe how SUV and train got snagged by rail

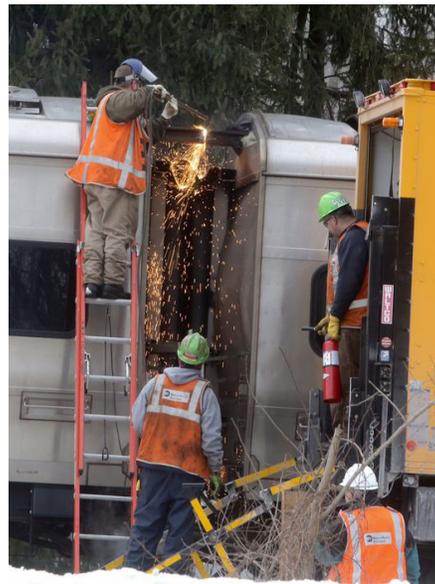
“When the train hit the SUV and was pushing it along, the SUV snagged that end of the third rail and pulled it off the insulators that hold it,” said Steve Ditmeyer, an adjunct professor of railway management at Michigan State University. “That caused it to come up through the SUV and into the lead car of the train.”

*The third rail punctured the Metro-North train’s first car and ended up near the roof and between the first and second cars after the Tuesday evening crash. A portion of third rail is cut Wednesday as workers begin the process of removing the wreckage. (Photo: Seth Harrison/The Journal News)*
