# Mechanistic design for Concrete Crossties

Application for Amtrak's Shared  
Corridor Application

2018 International Crosstie and  
Fastening System Symposium

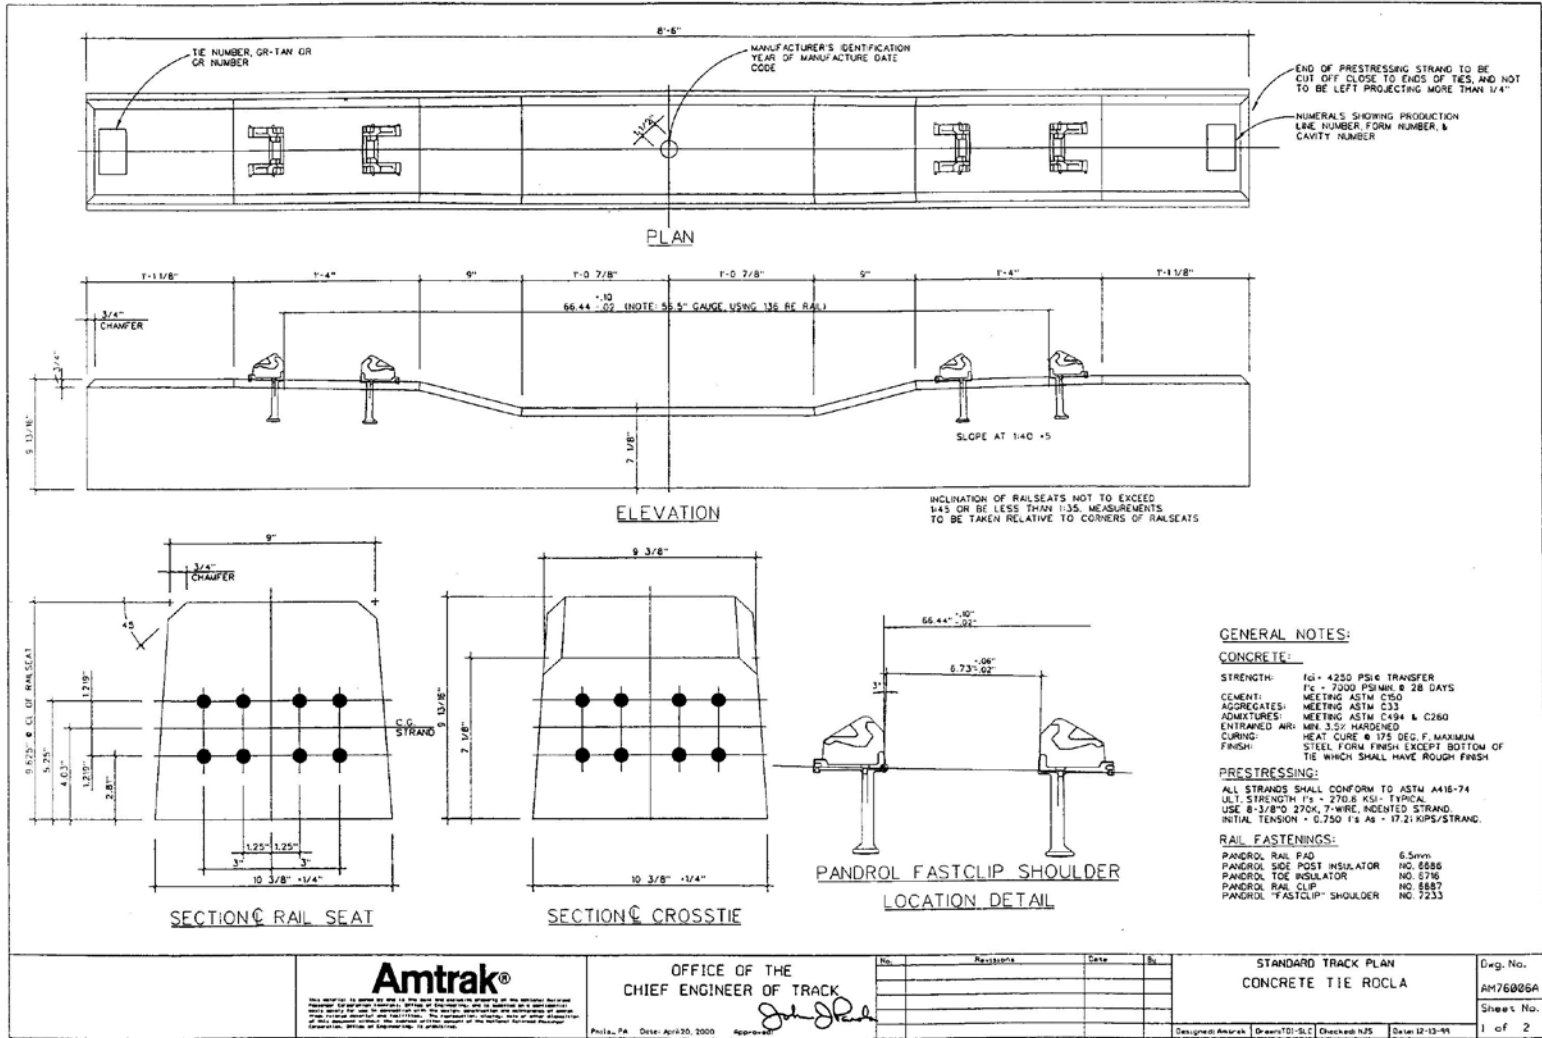
Dwg. No.  
AM76006A  
Sheet No.  
1 of 2

STANDARD TRACK PLAN  
CONCRETE TIE ROCLA

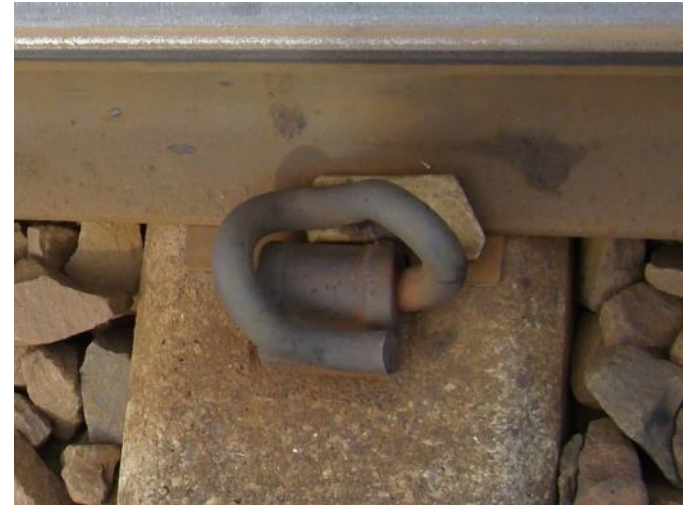
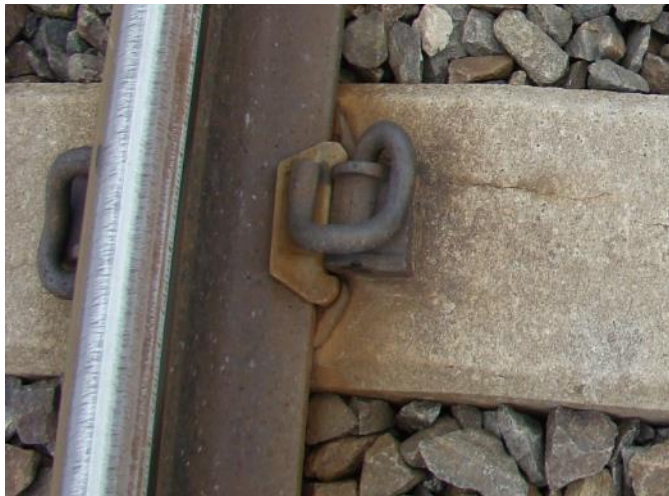
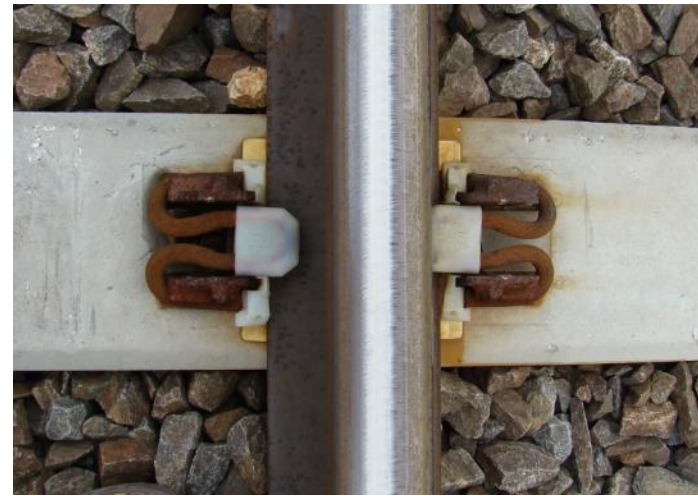
- 1978-1986 PR 601-A
- 1990- 1995 e 2055
- Mid 1995 to present FastClip

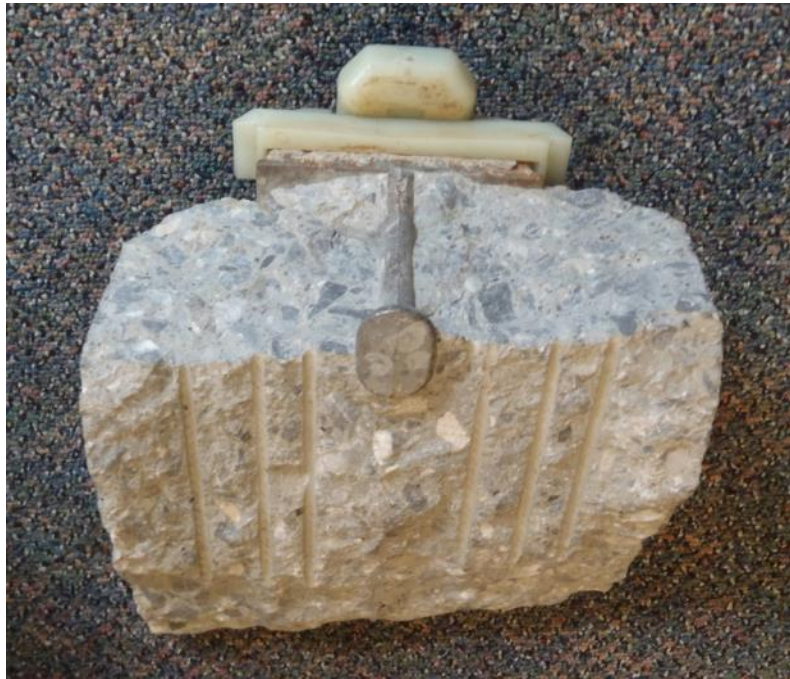
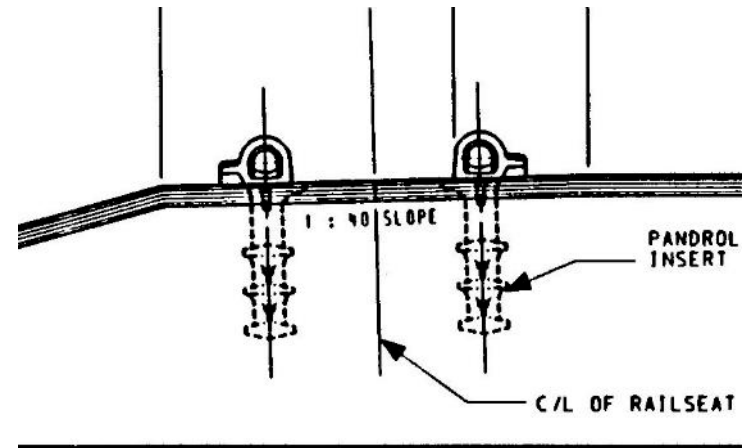
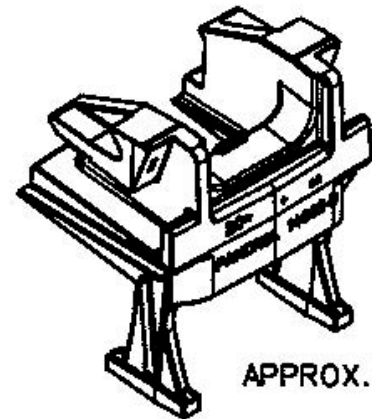
- 1983-1995 Single bi-axial ragged stem
- 2003 Single button stem
- 2010 Double stem FastClip

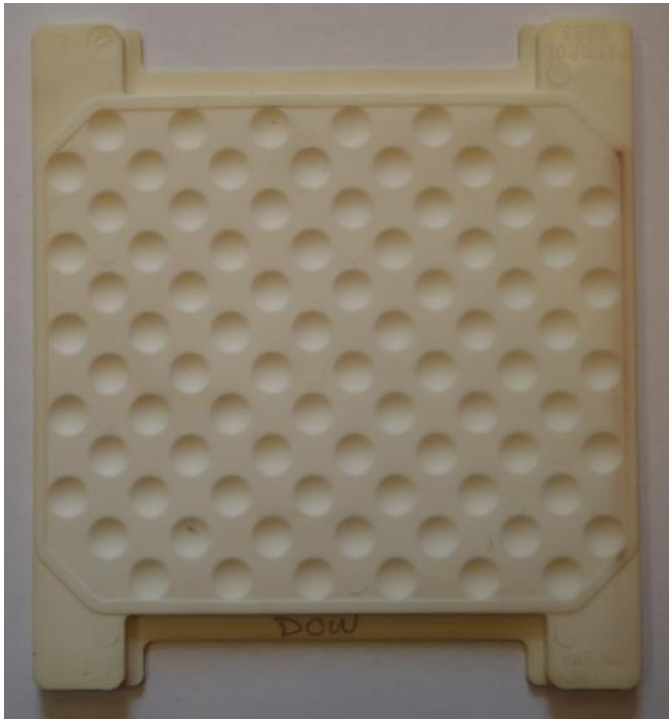
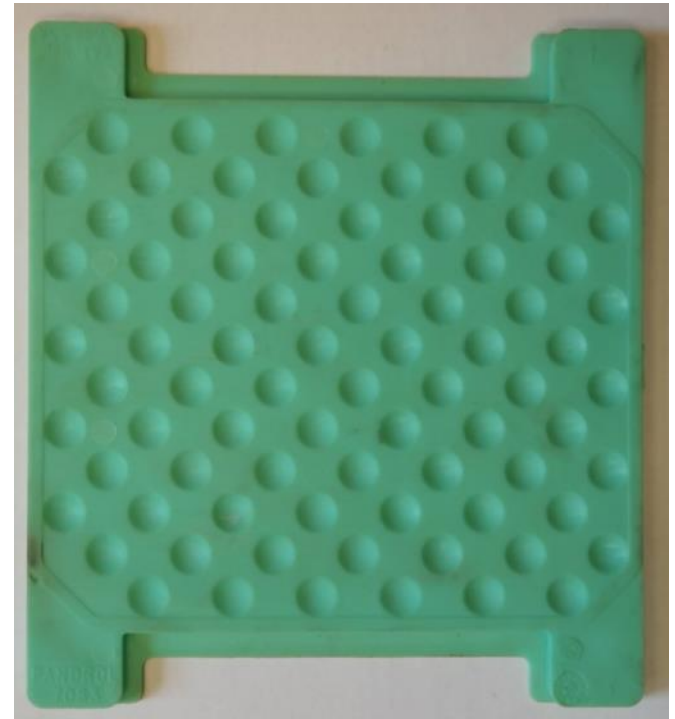
- 5 mm Ohio rubber pad
- 6 1/2 mm irradiated EVA pad
- 6 1/2 mm polyurethane pad (KD, WB)

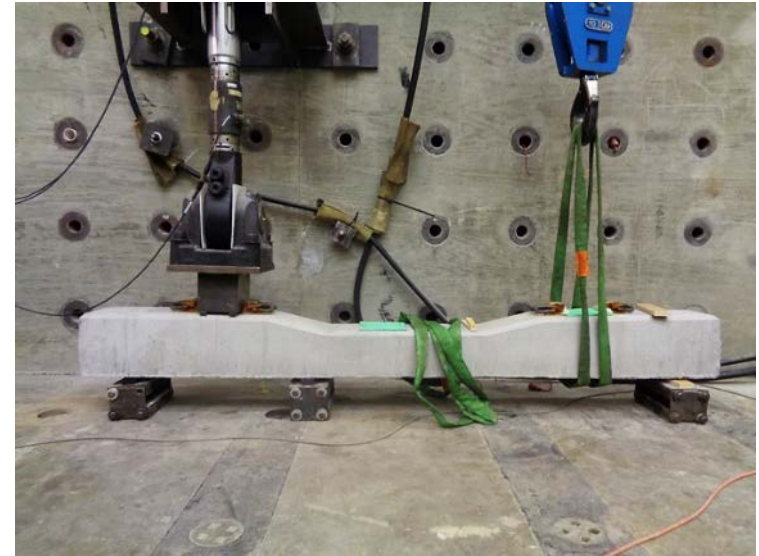
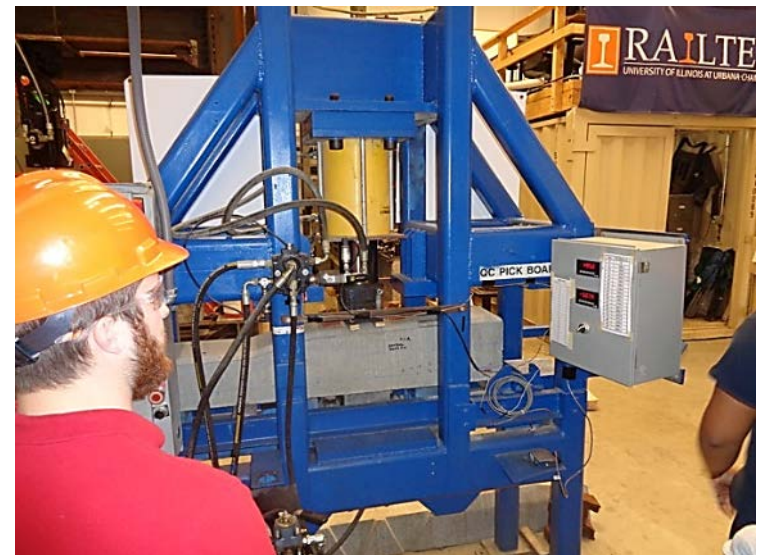
- ▶ Baseline for experimental matrix is the current AREMA design validation sequence of tests (4.9.1)
- ▶ Additional tests (developed at UIUC) were added to facilitate a quantitative comparison of performance
  - Load at first crack
  - Load vs. deflection curves at the center and the rail seat

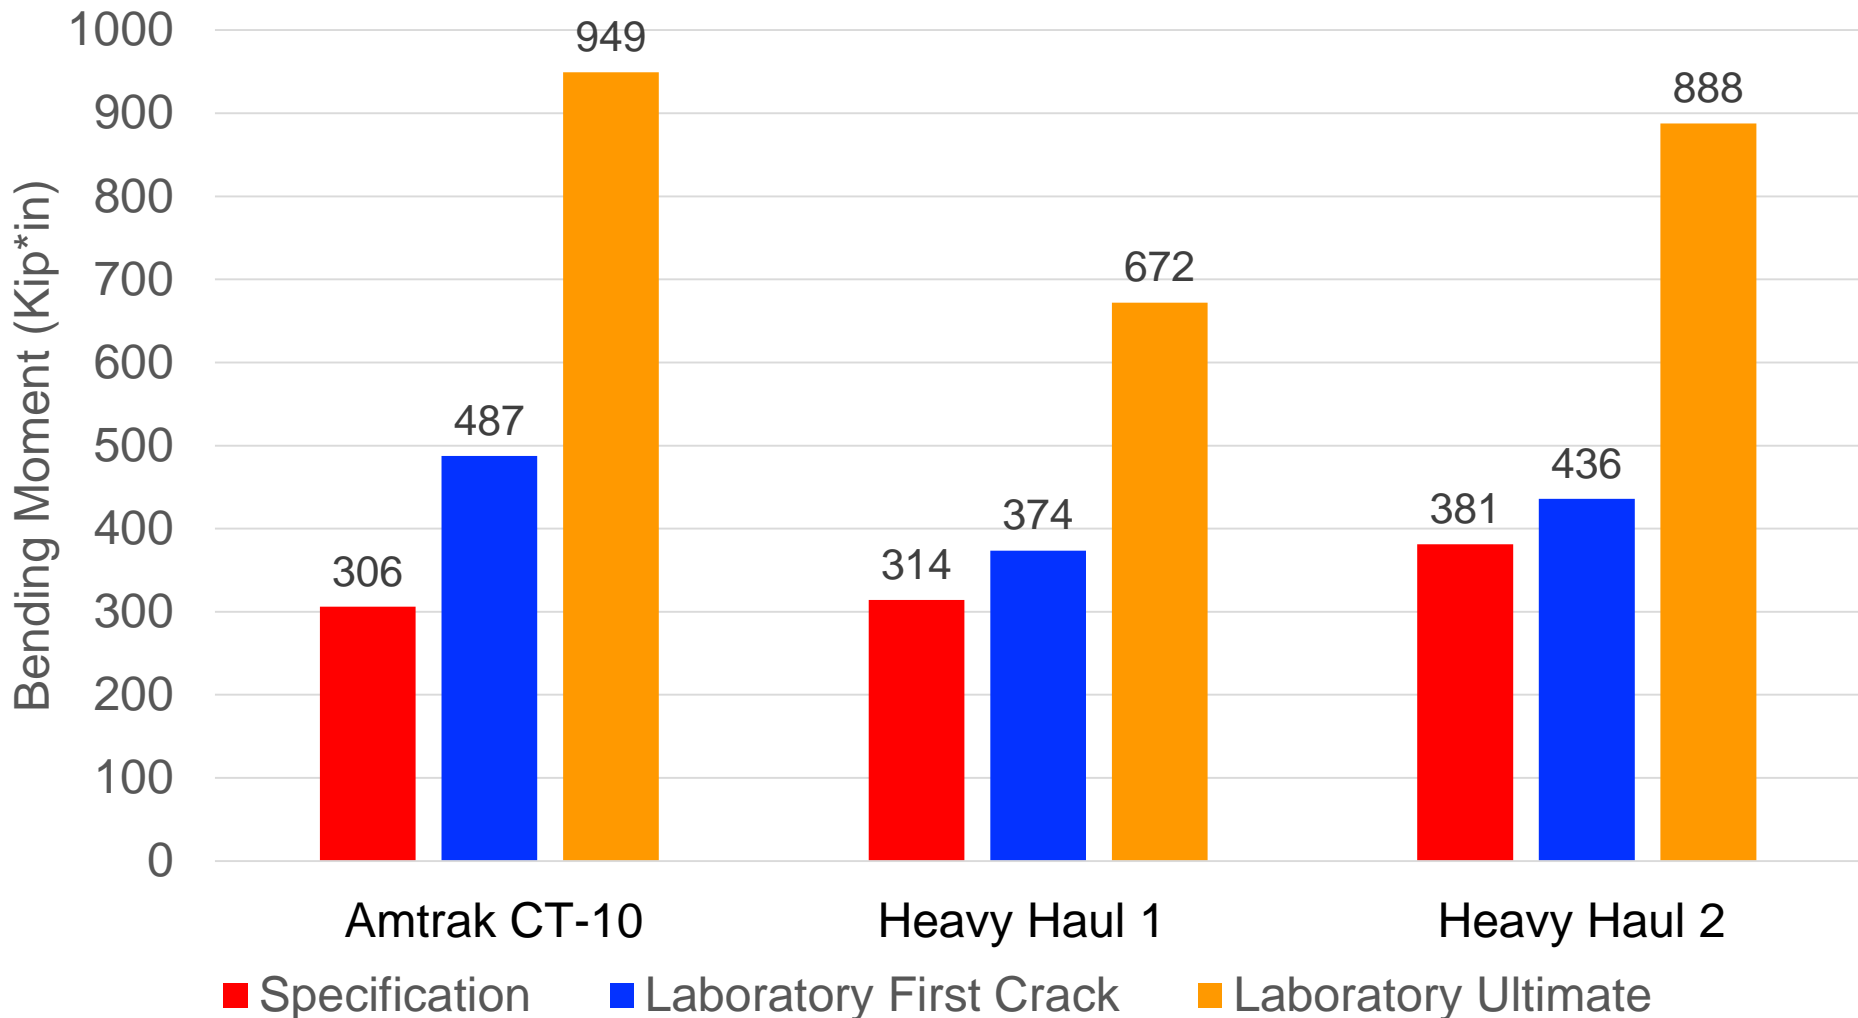
## Rail Seat Positive Testing (RS+)

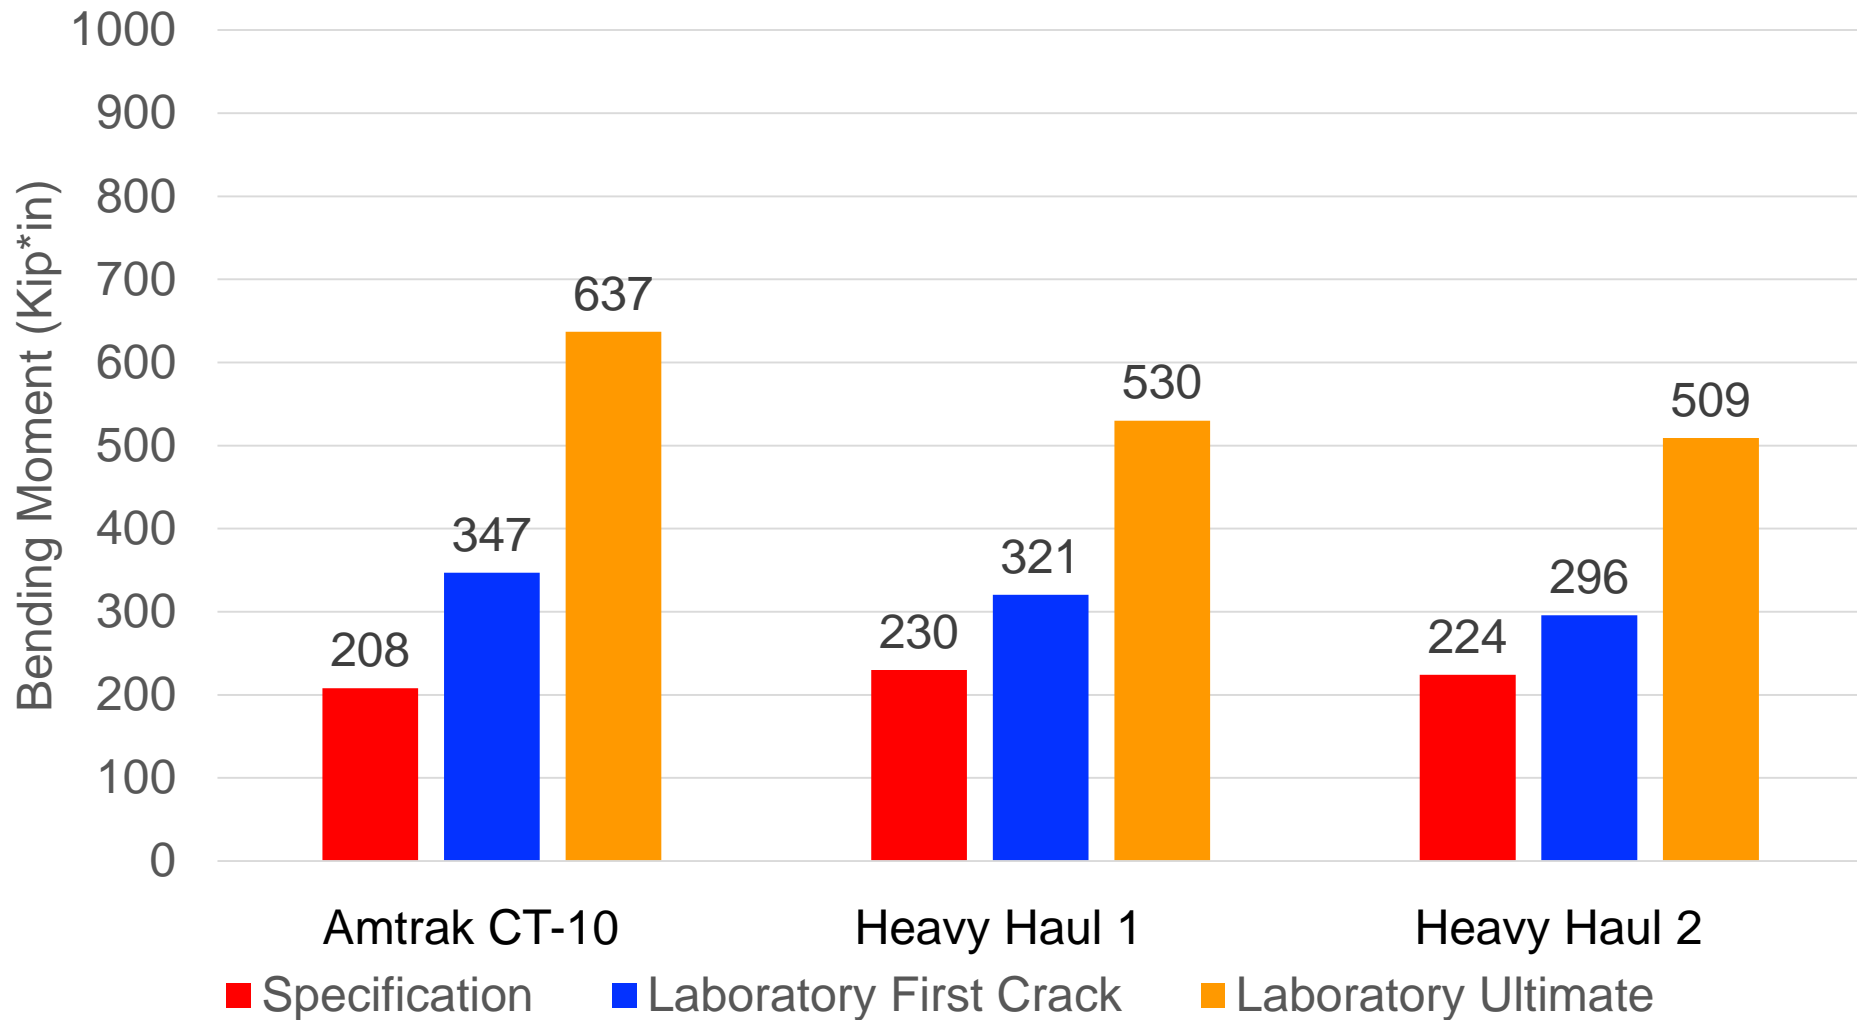
## Center Negative Testing (C-)

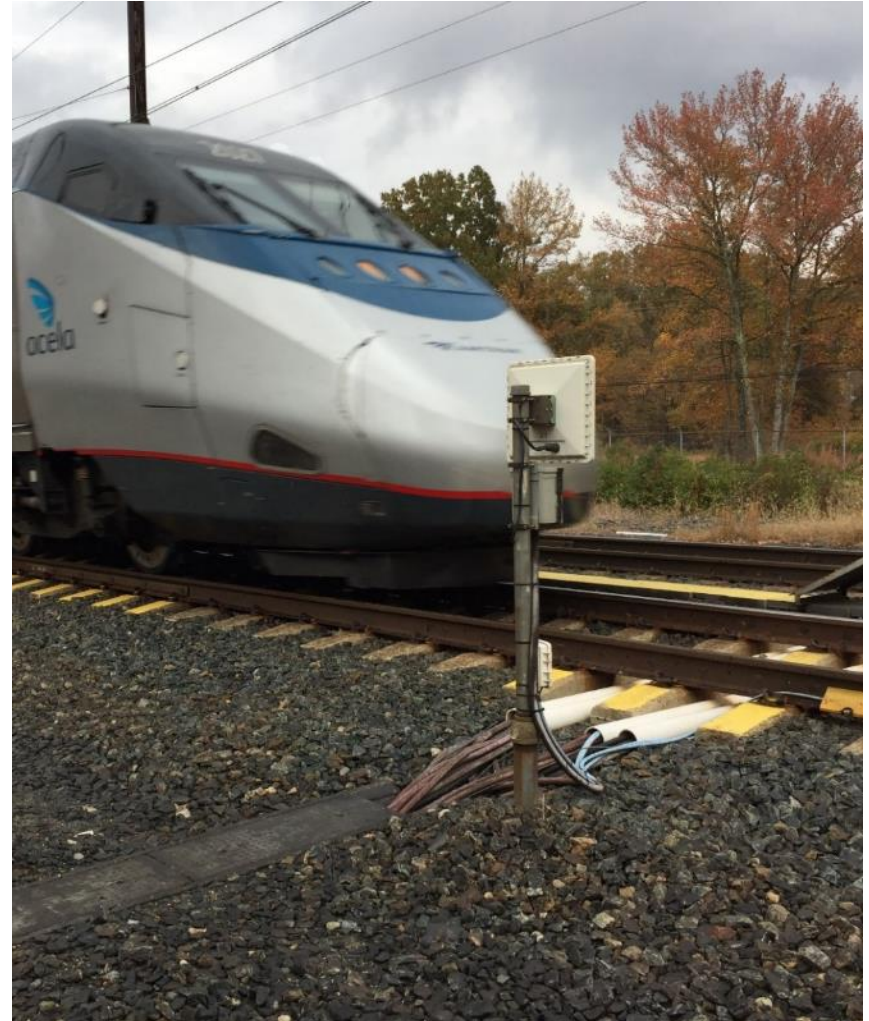
## WILD Results Overview

- ▶ Data analyzed from 1 Jan to 30 June 2017
- ▶ Sites:
  - Edgewood, MD
  - Marcus Hook, PA
  - Mansfield, MA
- ▶ 54,156 trains
- ▶ 2,210,687 Axles
- ▶ 36.6 Million Gross Tons (MGT)

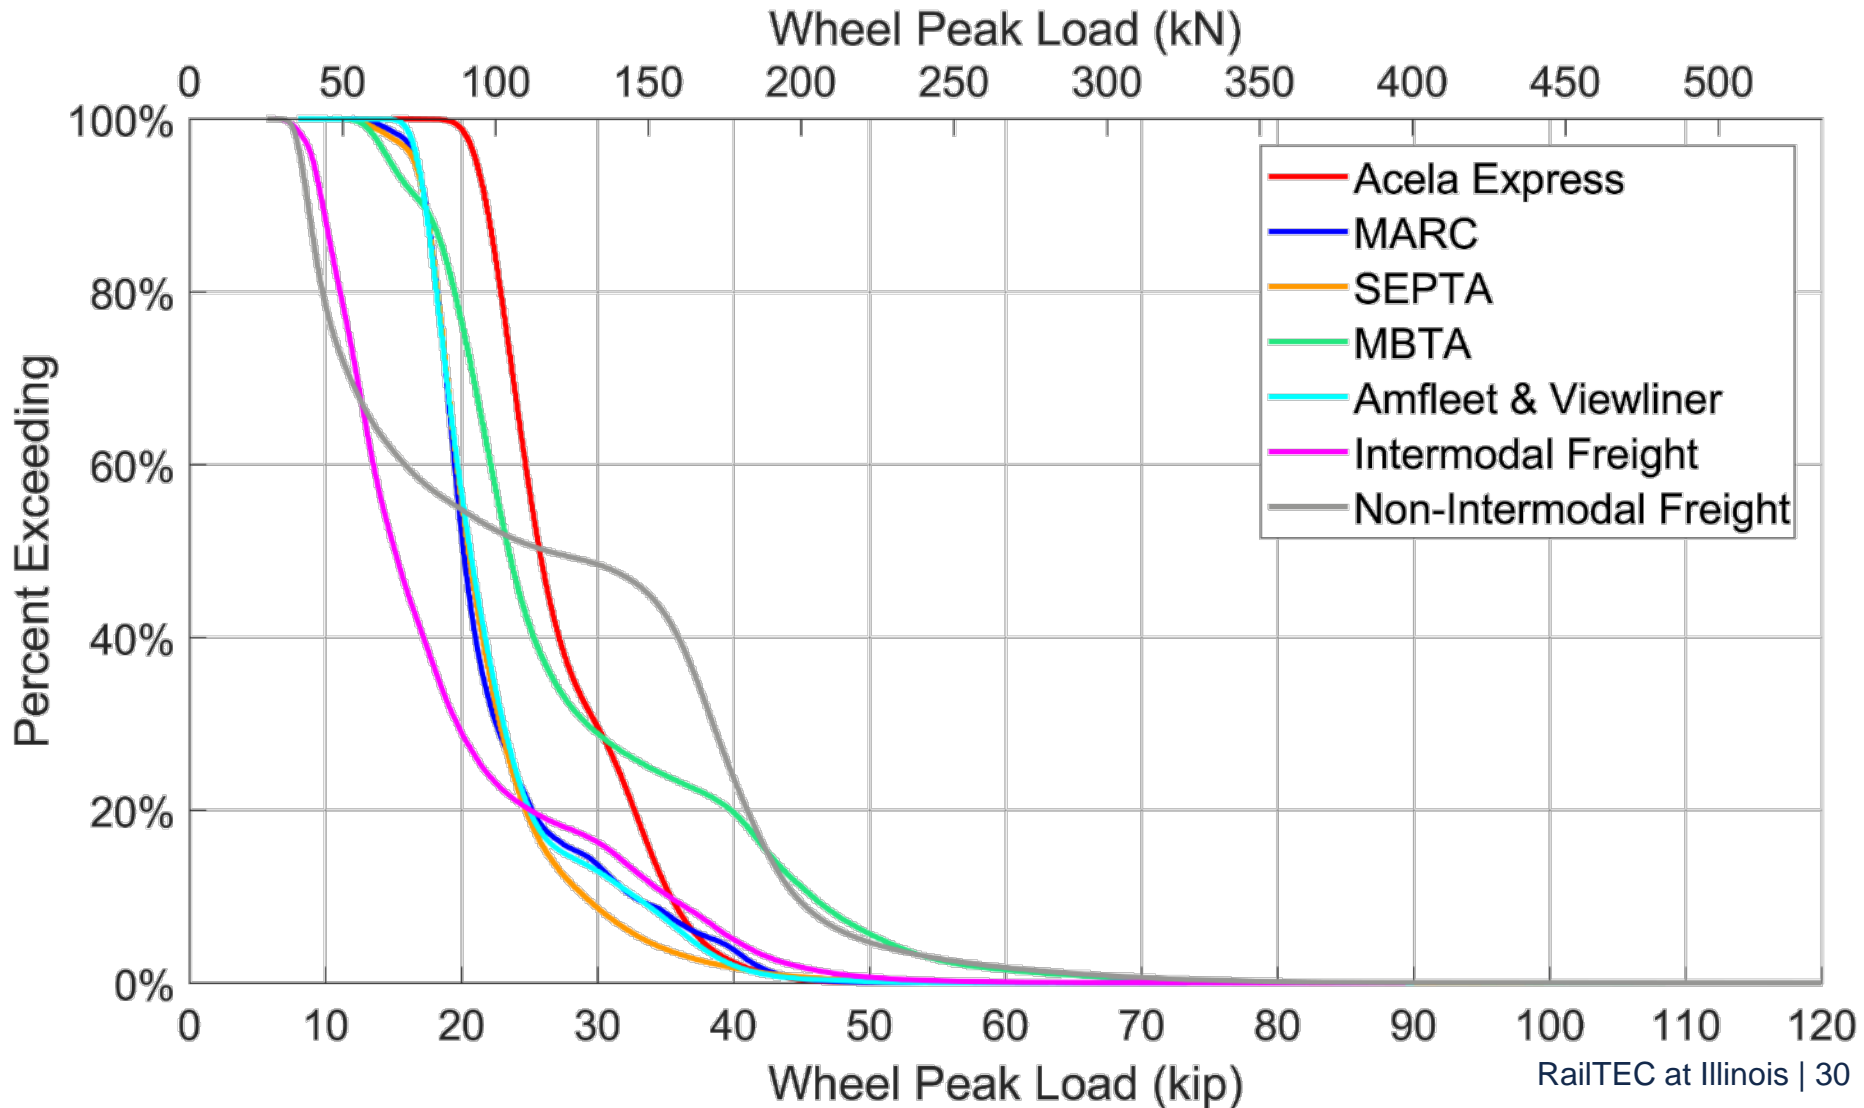
## WILD Site Results-Wheel Load Data

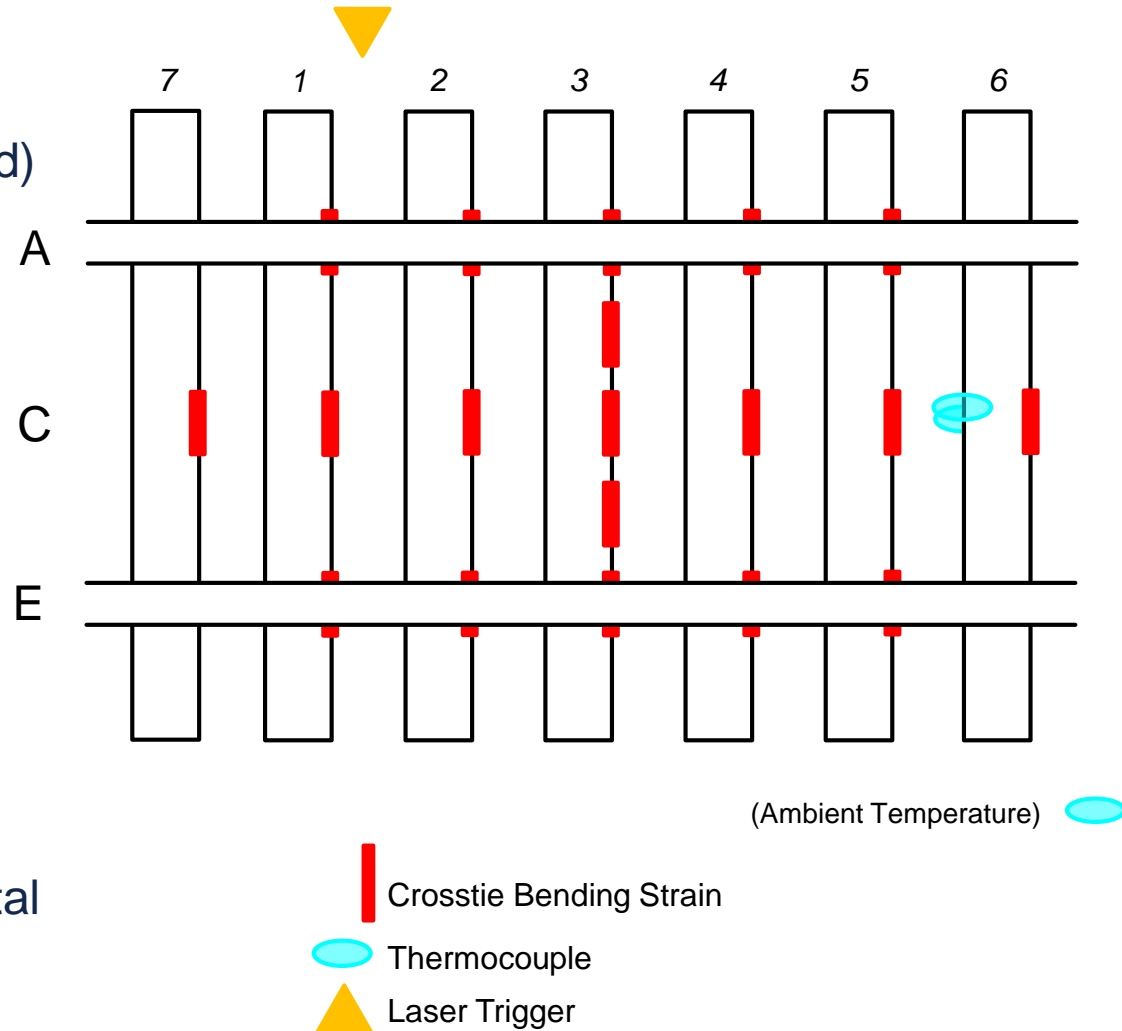
## Instrumented Crossties

- Site characteristics:
  - Track 2 (typically northbound)
  - Maximum allowable speed: 125 mph (201 km/h)
  - Tangent
  - Grade: 0.1%
- Traffic during data collecting phase:
  - 4,612 trains, 180,362 Axles
  - 13 December 2016 – 17 May 2017
  - 4.5 MGT out of 7.6 MGT total for the same time period.

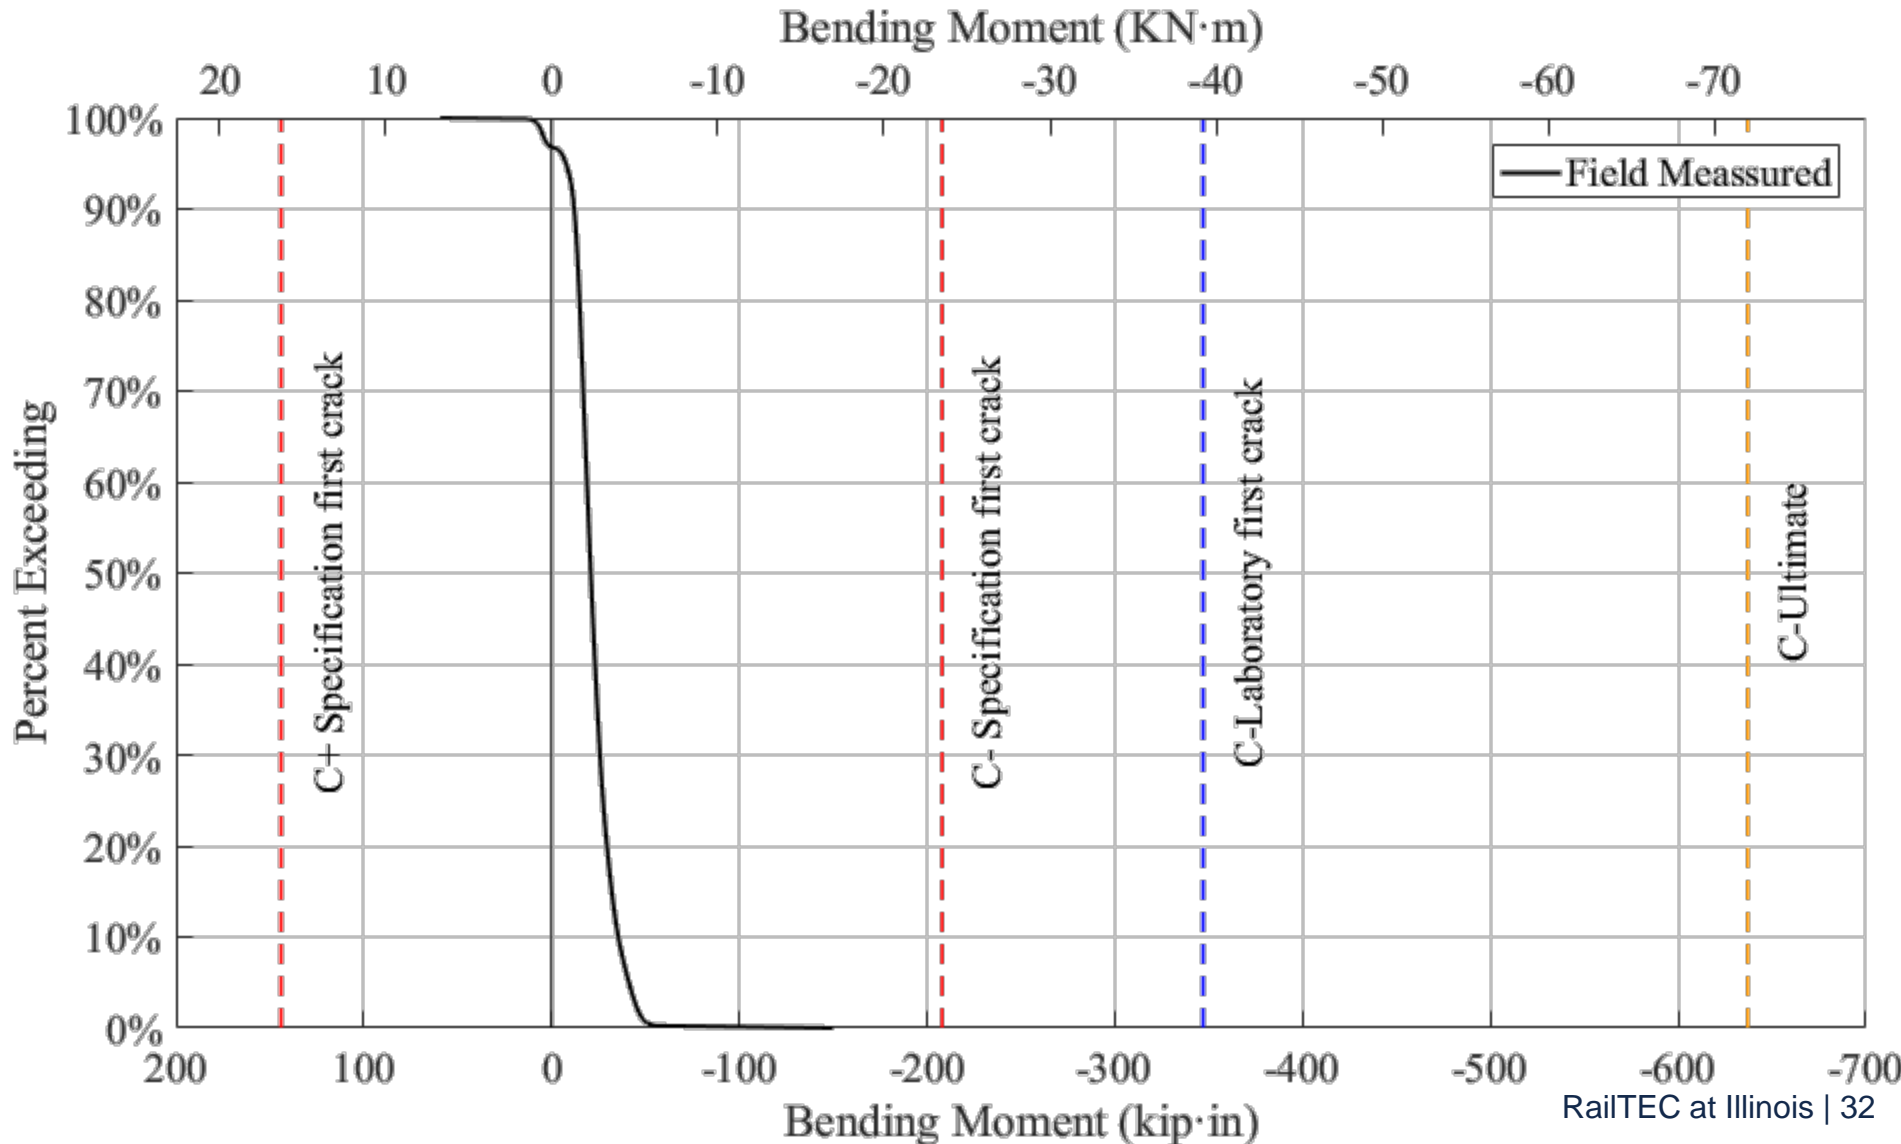
## Instrumented Crossties-Center Bending Moments

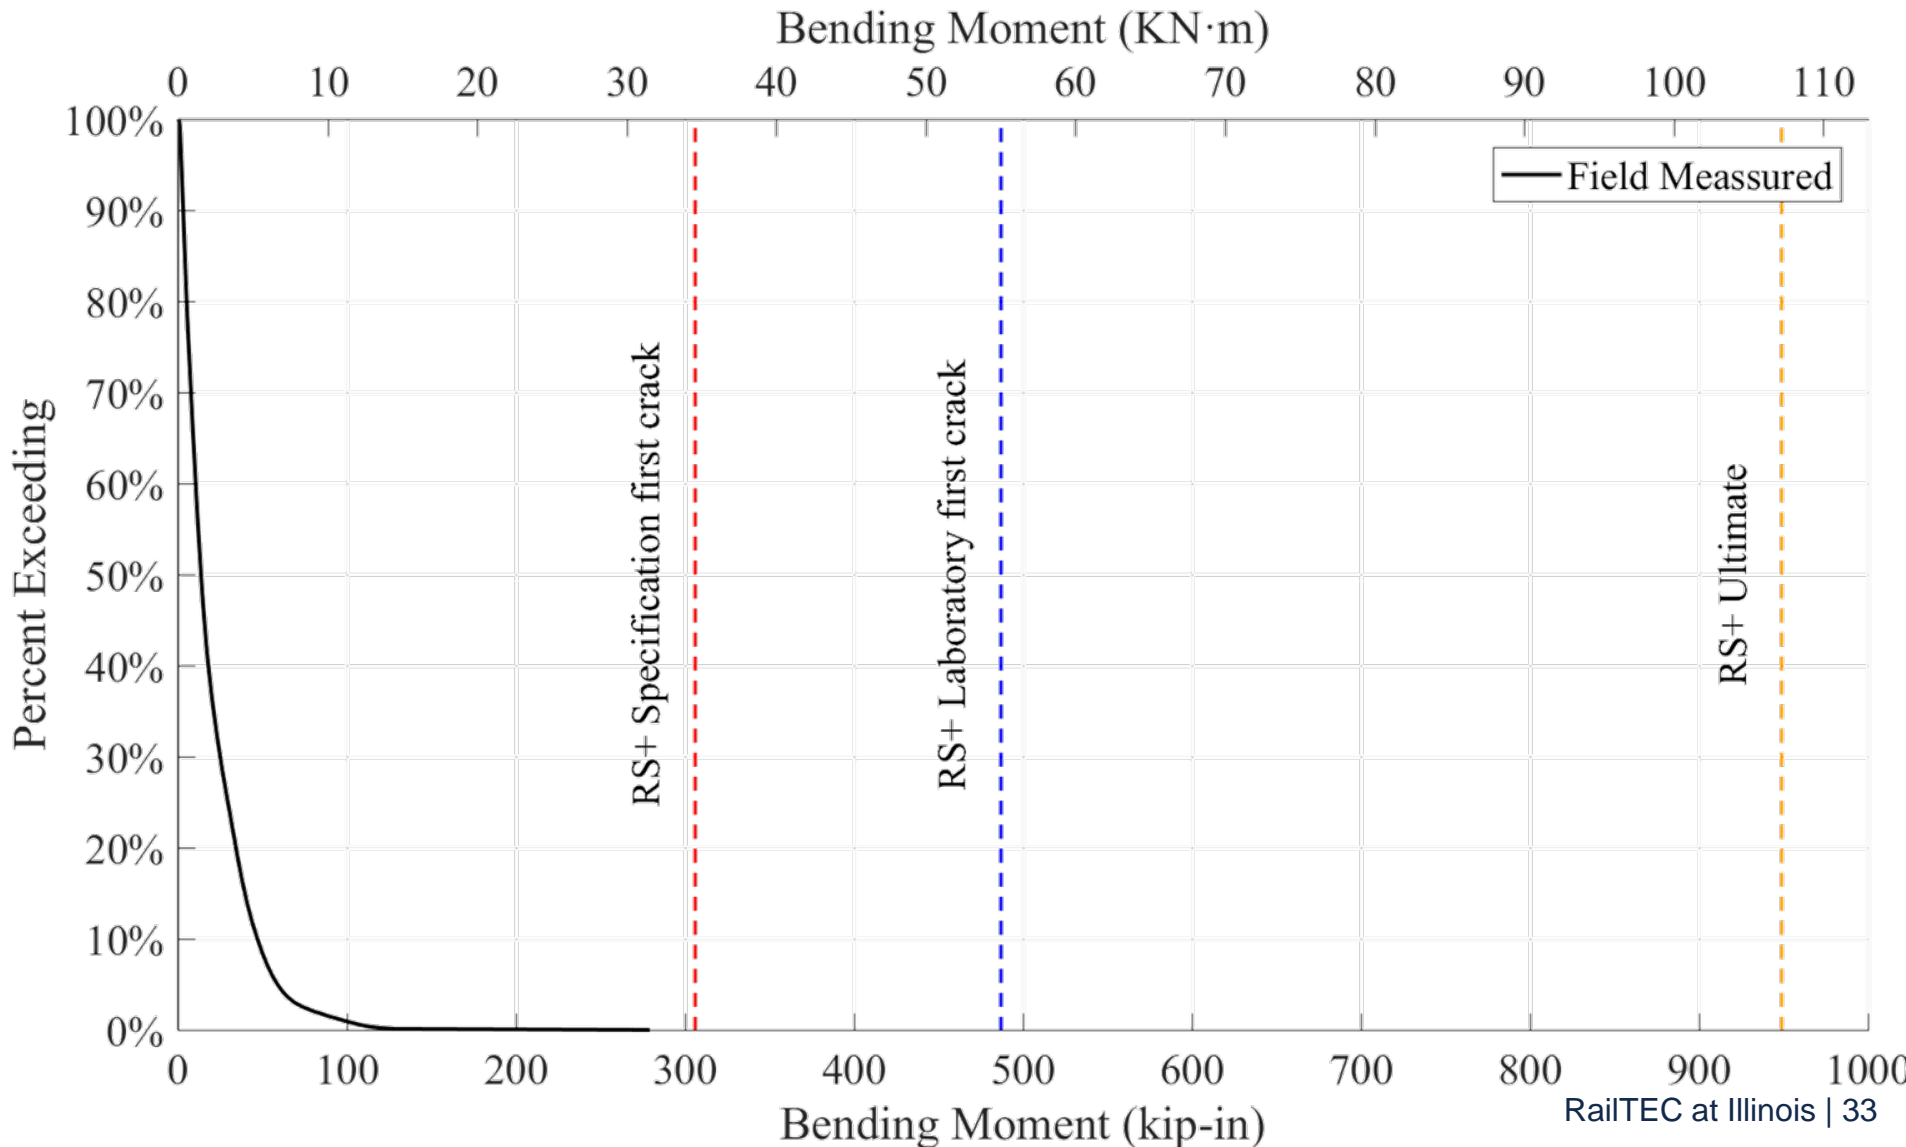
## Instrumented Crossties-Center Bending Moments

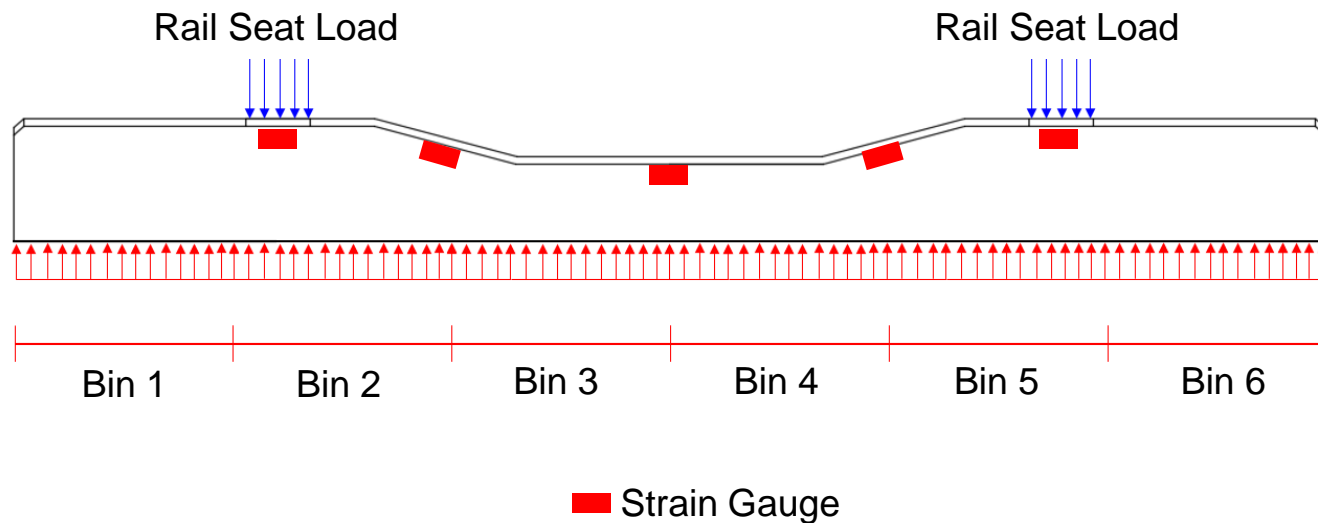
## Support conditions back calculator

- ▶ Using approach detailed by Gao et al. (2015) support conditions on site were estimated from strain gauge data
- ▶ Known parameters: 5 discrete strain locations and 2 rail seat loads
- ▶ Results are given in terms of percentages of support under 6 discrete bins

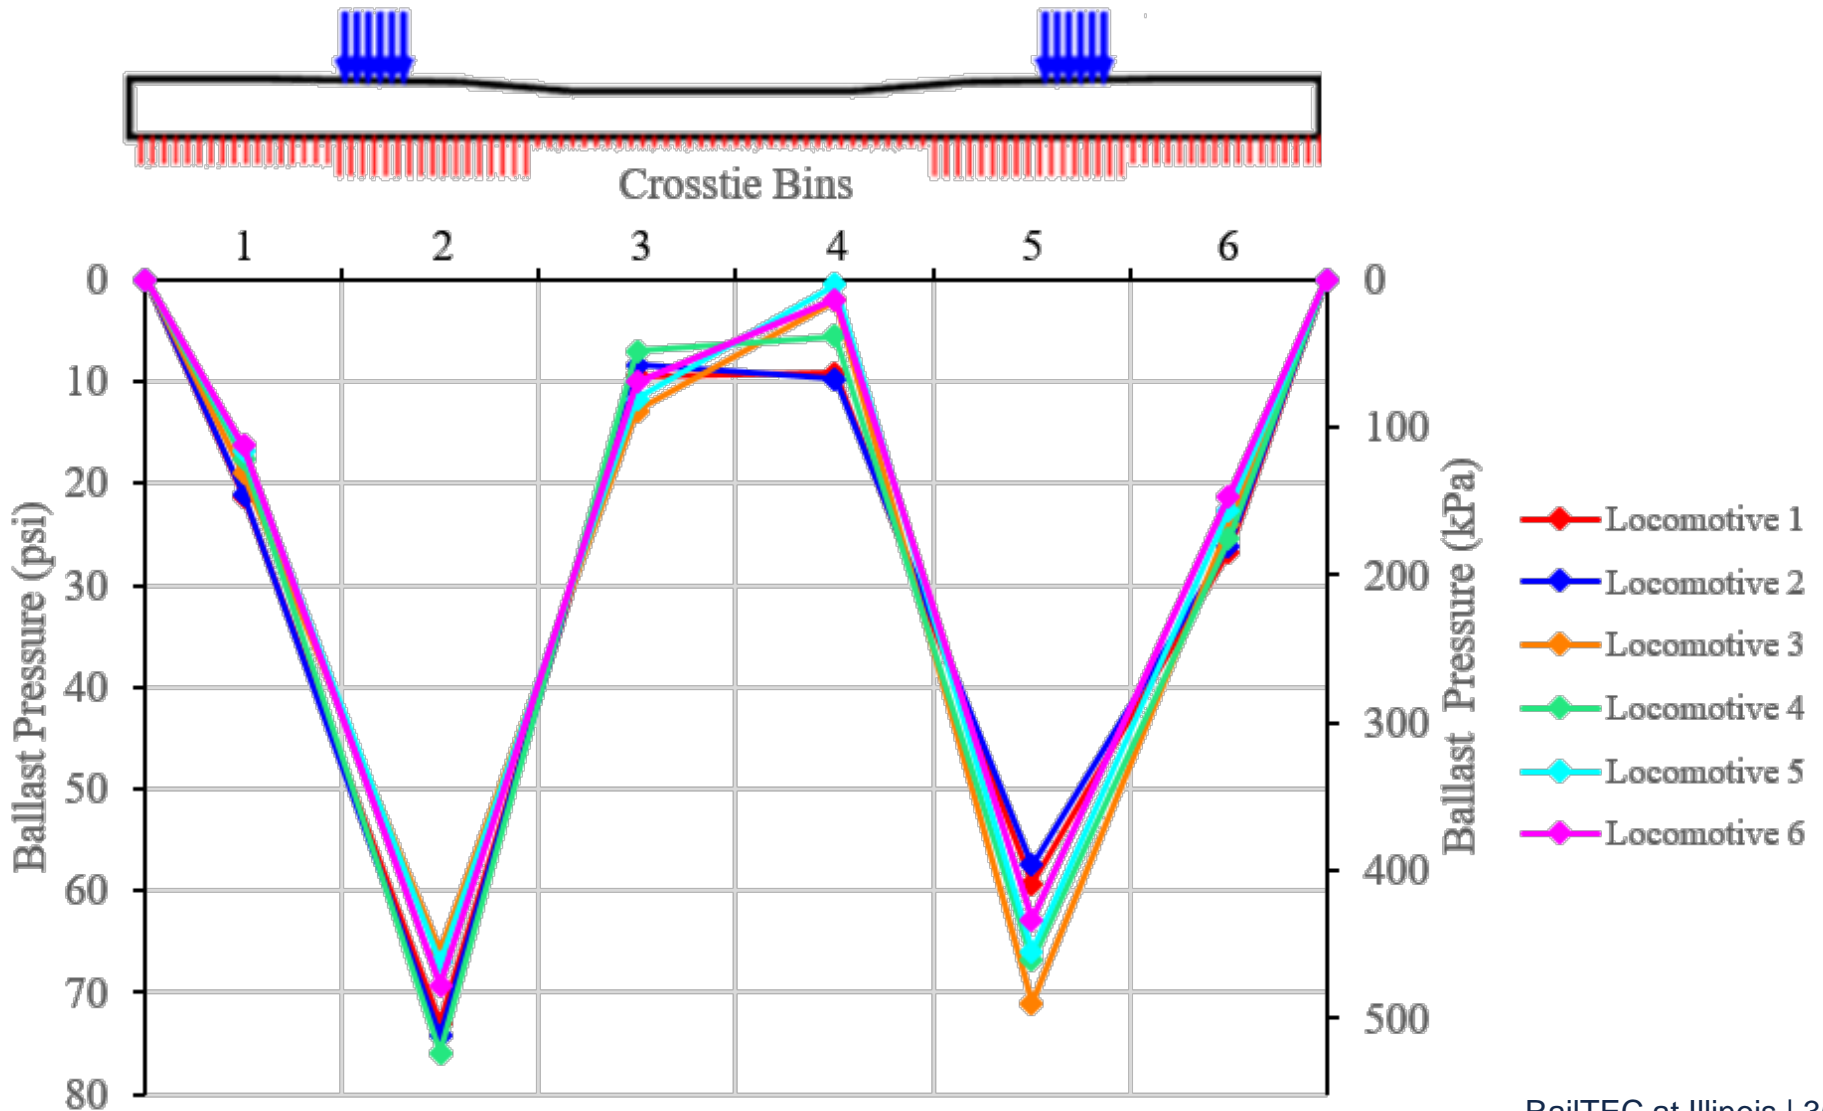
## Support conditions back calculator

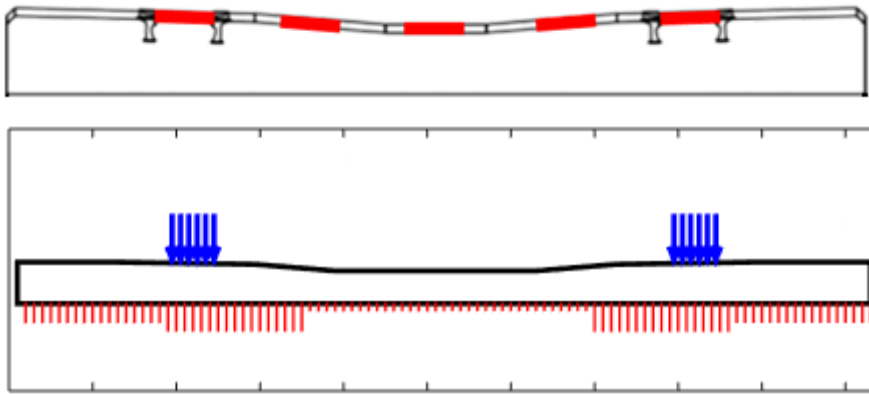
Good Rail Seat support

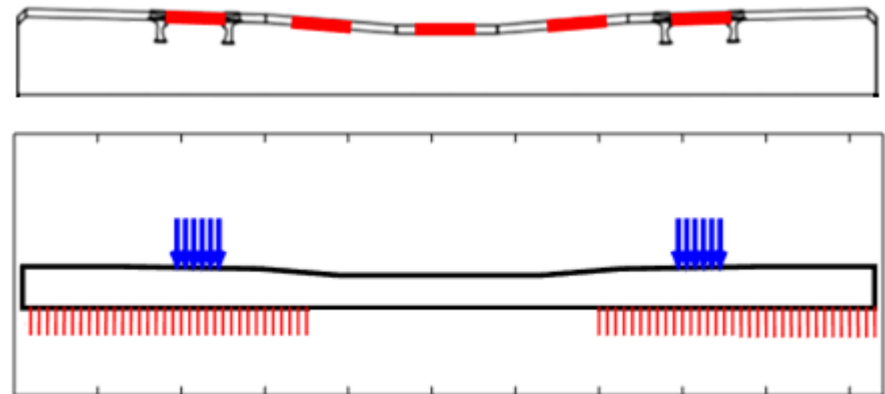
Lack of Center Sup.

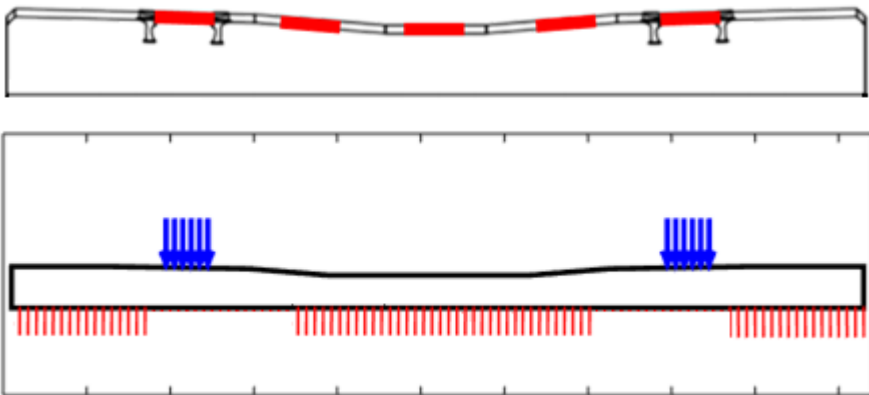
Lack of Rail Seat Support

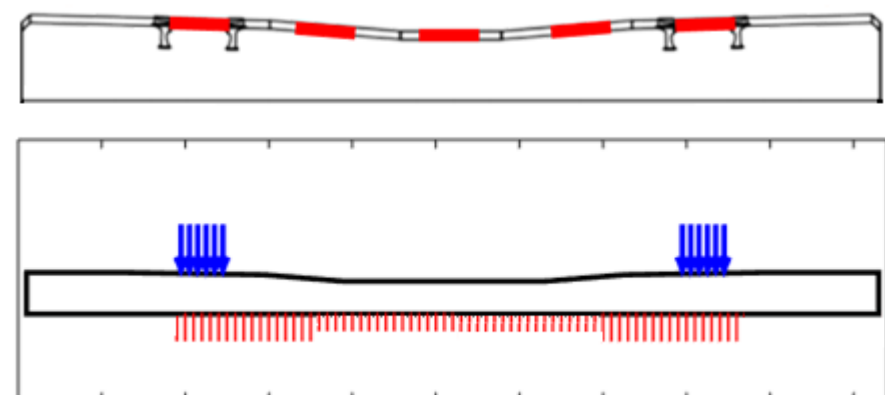
Moderate Center Binding
