# Mechanistic design for Concrete Crossties

Application for Amtrak's Shared  
Corridor Application

2018 International Crosstie and  
Fastening System Symposium

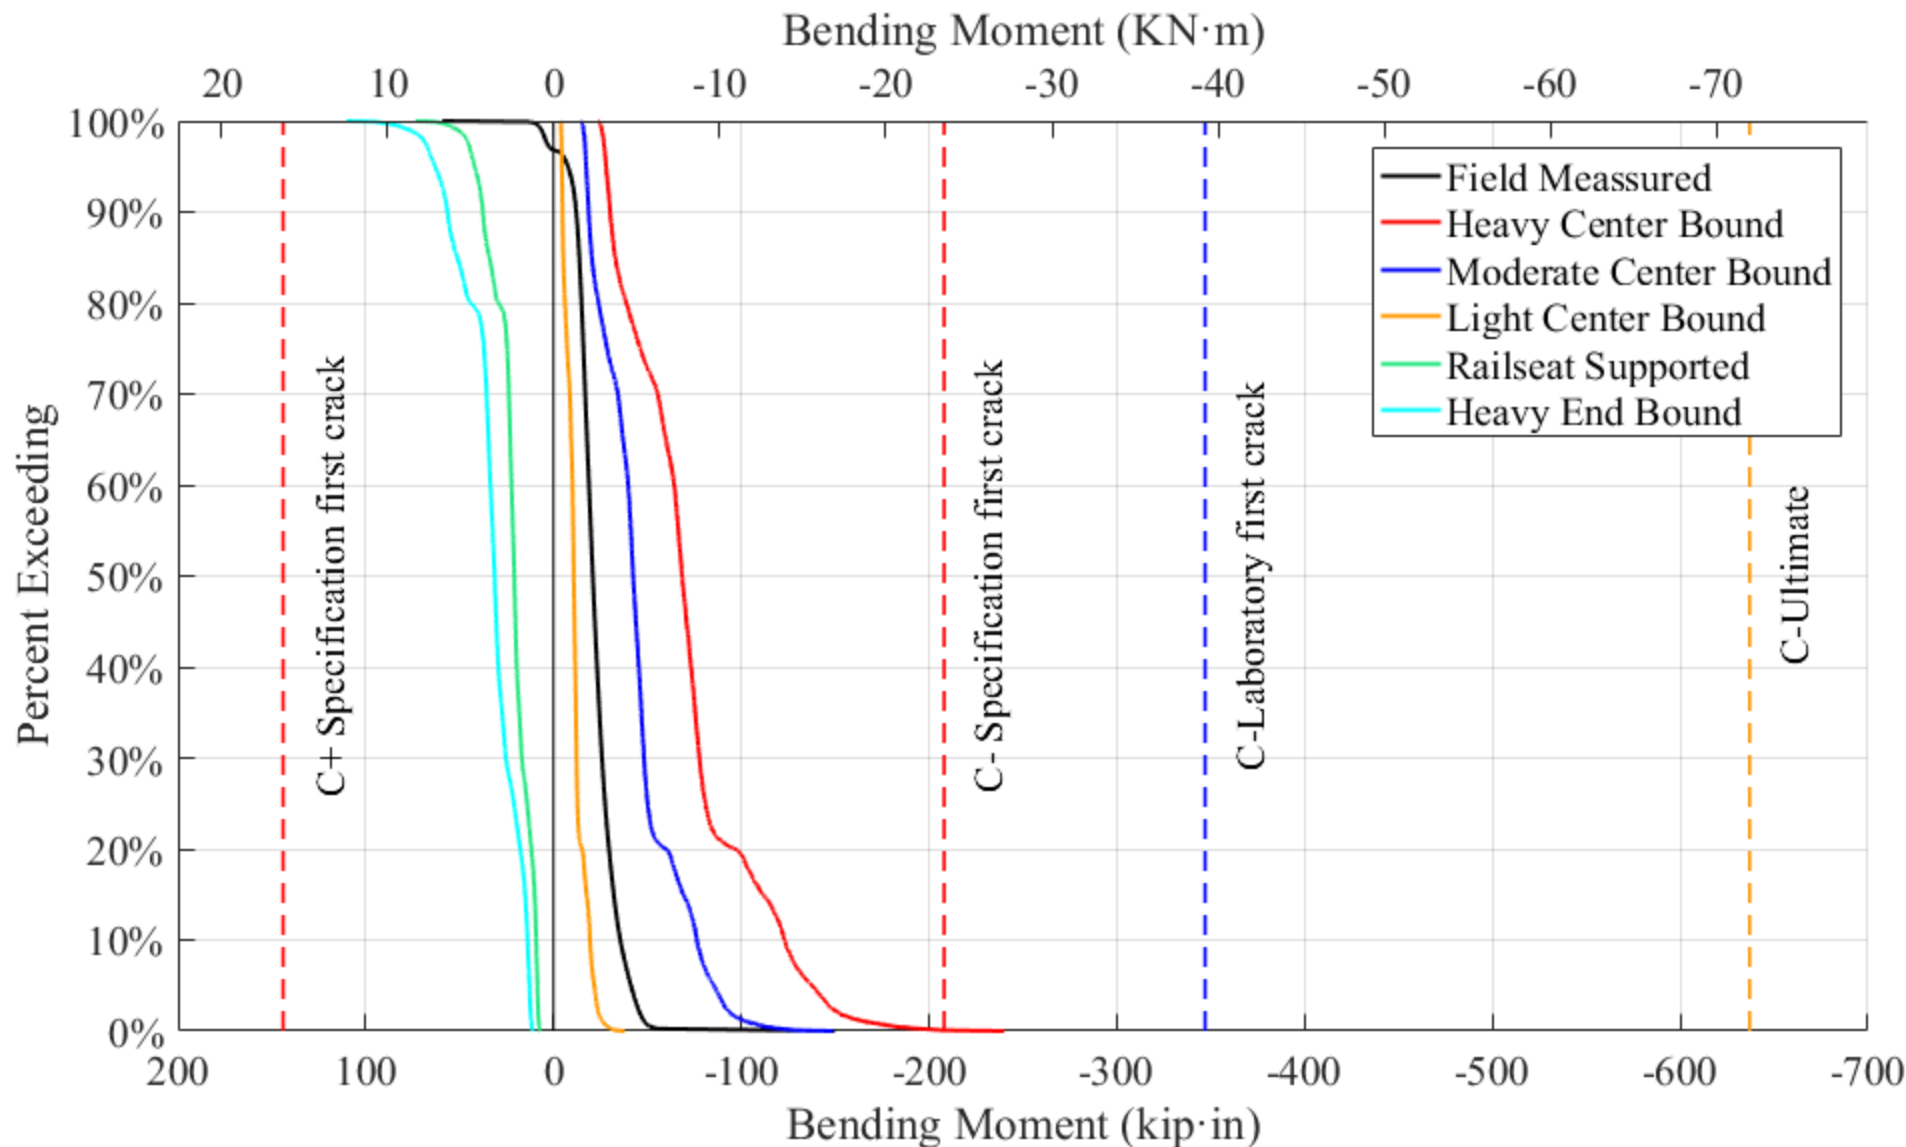
## Extrapolated Center Demand

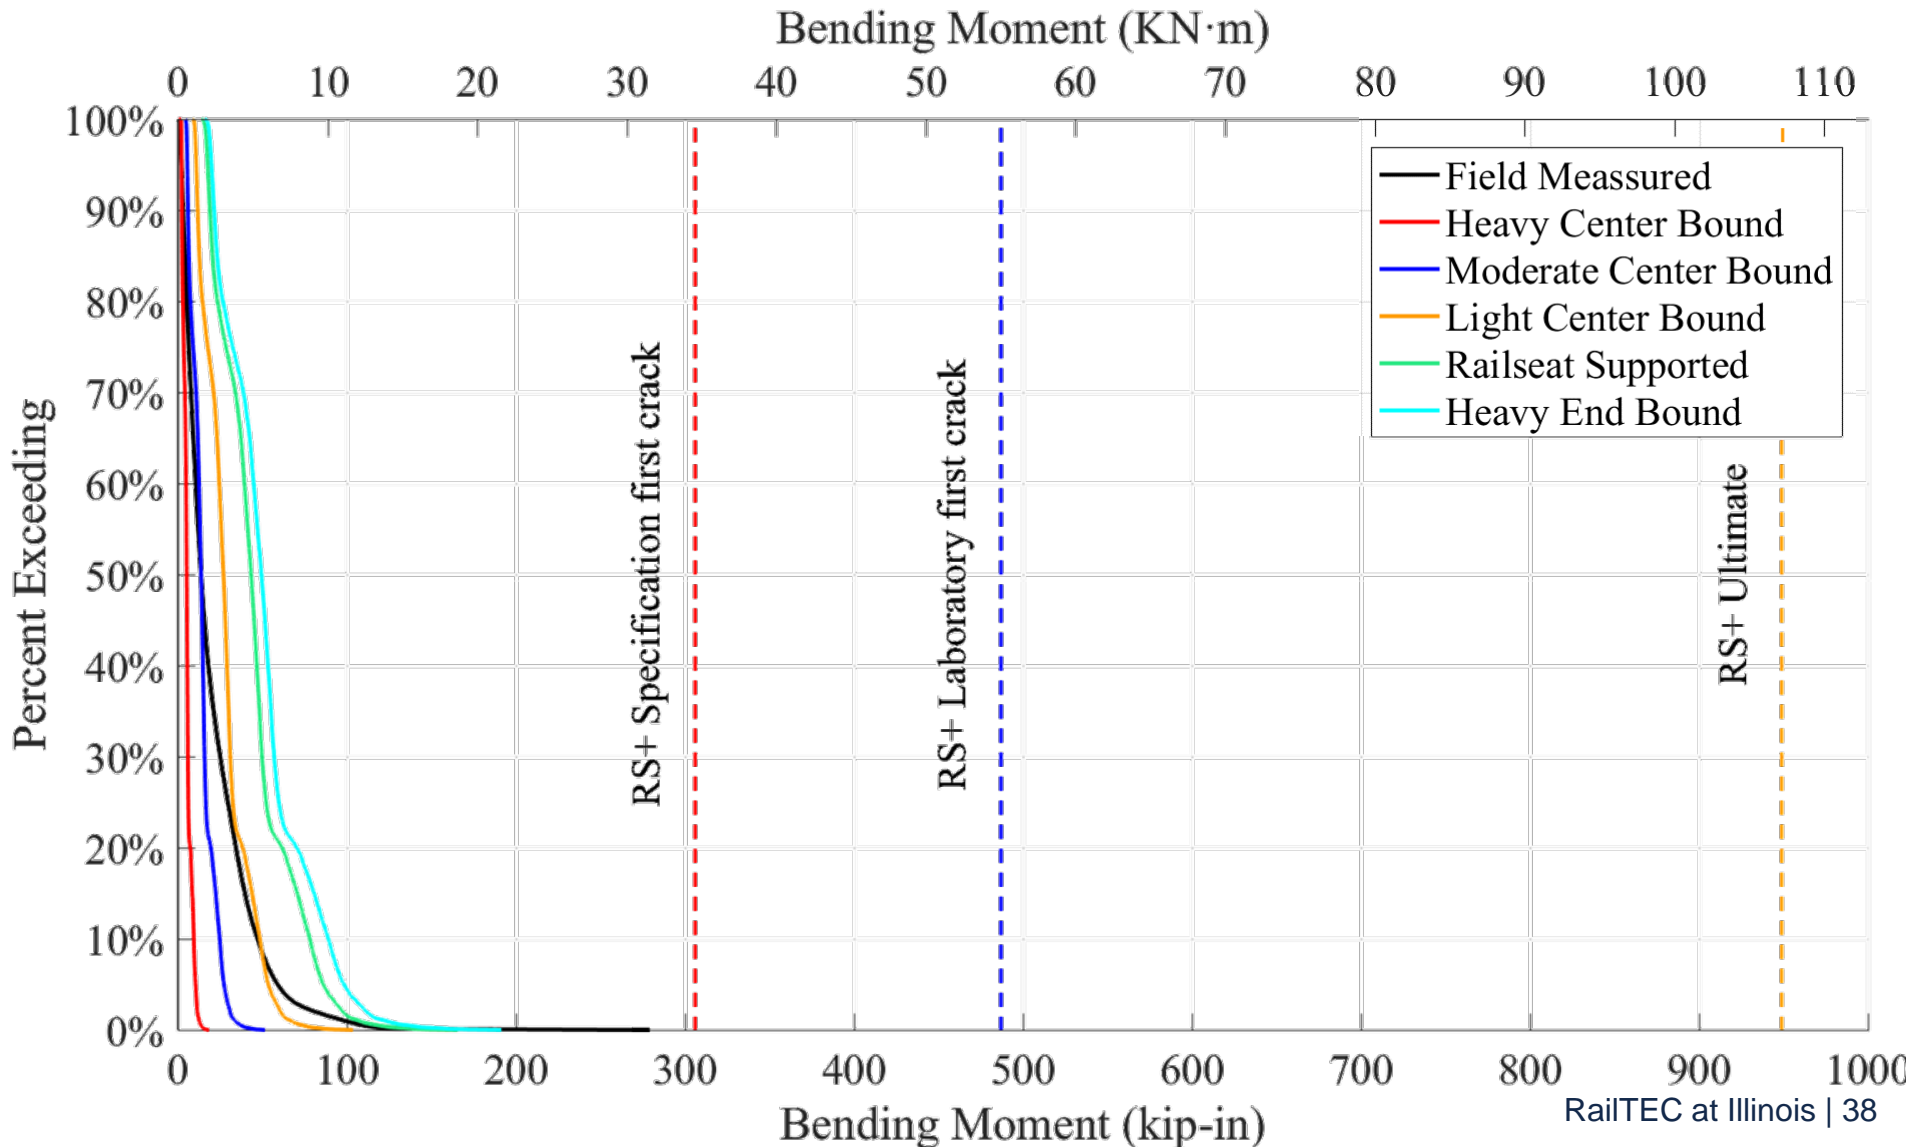
## Extrapolated Rail Seat Demand

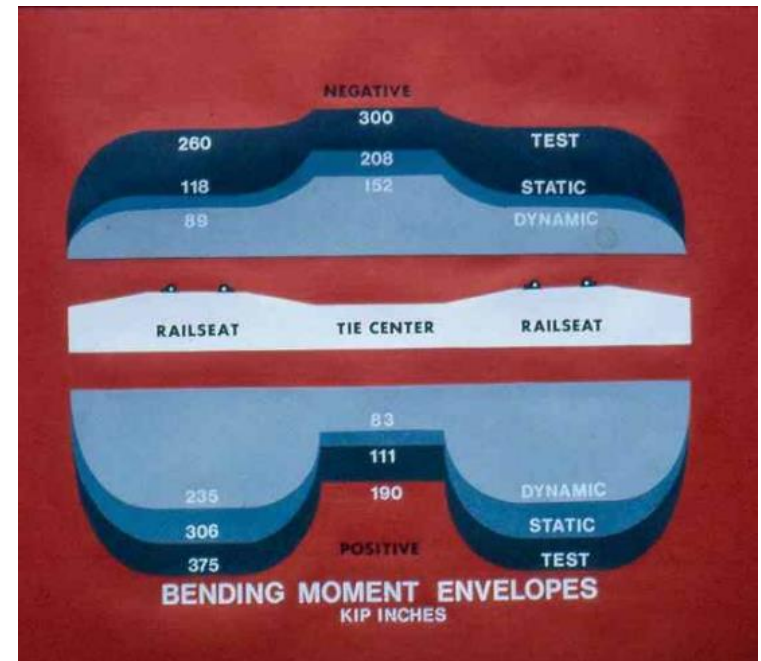
- Clean slate design
  - Balanced capacity
  - Optimized cross section
  - New technologies

Center Negative (C-)	Rail Seat Positive (RS+)
<b>245 kip-in</b>	306 kip-in
